SCREENING SITE INSPECTION REPORT  
FOR  
CARSTAB CORP  
READING, OHIO  
U.S. EPA ID: OHDO00724138  
SS ID: NONE  
TDD: F05-9008-013  
PAN: FOH0022SA

AUGUST 19, 1991

**ecology and environment, inc.**

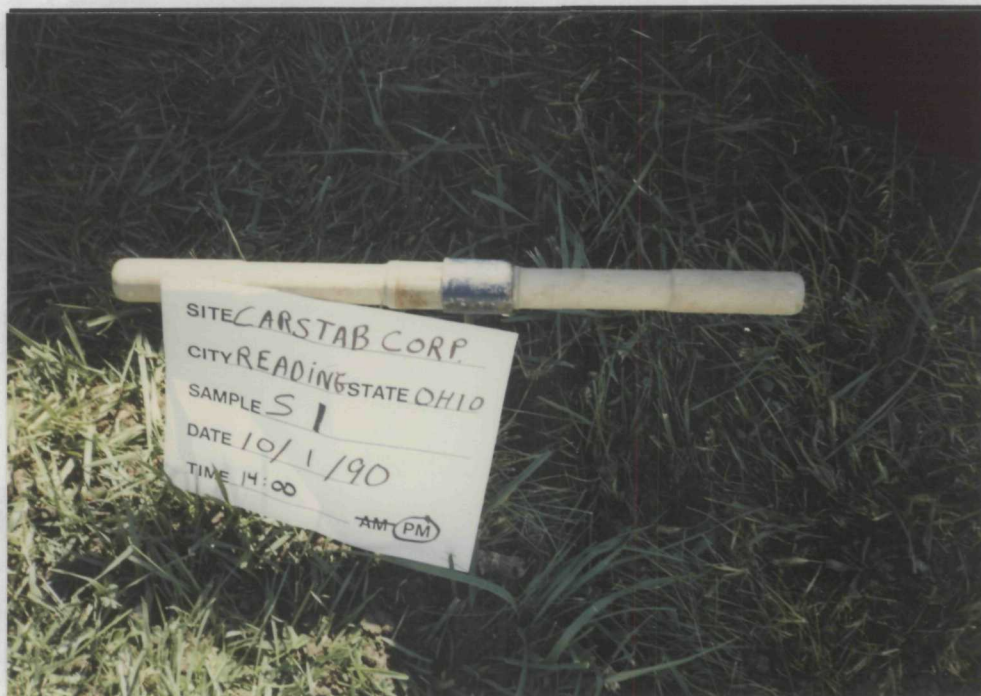
Cortney SchmidtSAMPLE ID  
(if applicable):S-1

DESCRIPTION: A close-up photo of Soil Sample location  
S-1.DATE: 10/1/90TIME: 14:00DIRECTION OF  
PHOTOGRAPH:SouthWEATHER  
CONDITIONS:ClearTemp  $\approx$  70°F

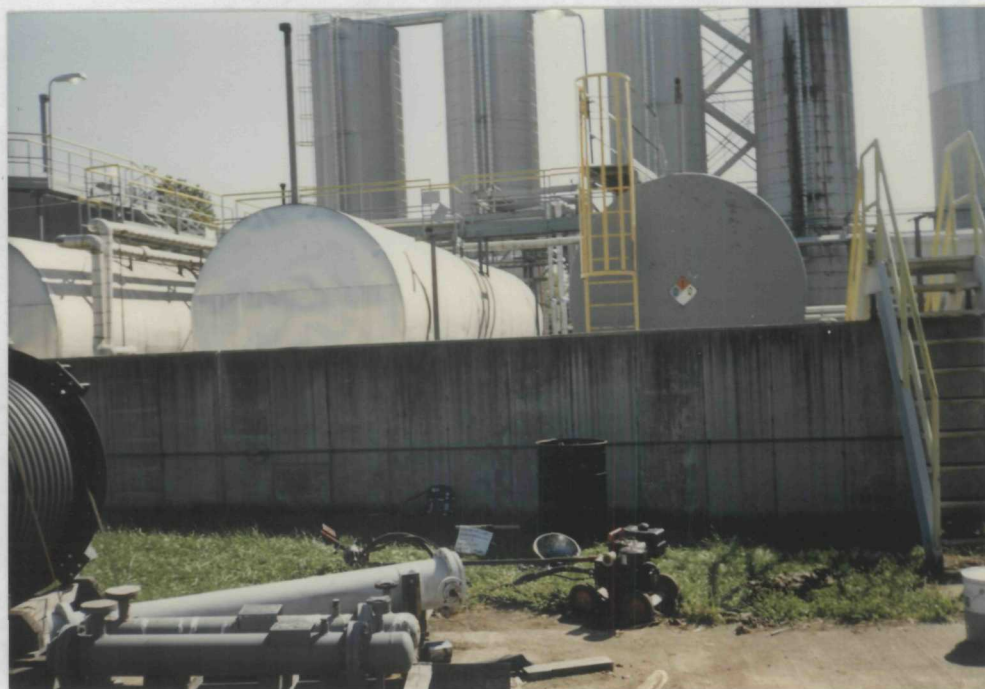
Cortney SchmidtSAMPLE ID  
(if applicable):S-1

DESCRIPTION: A perspective photo of Soil Sample location  
S-1

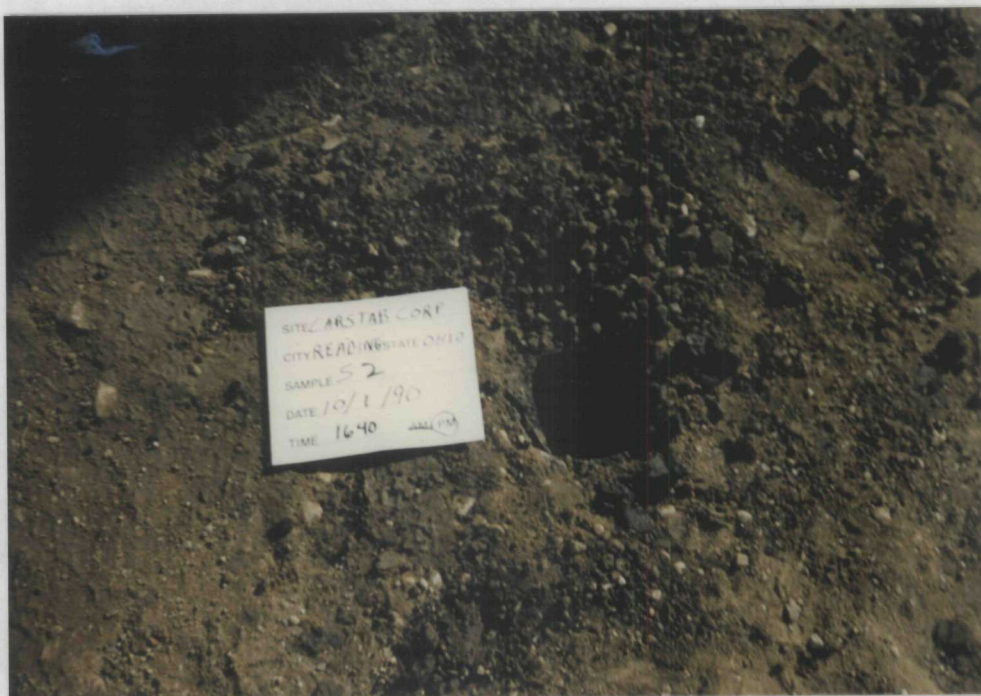
Cortney SchmidtSAMPLE ID  
(if applicable):S-2

DESCRIPTION: A close up photo of Soil Sample location  
S-2DATE: 10/1/90TIME: 16:40DIRECTION OF  
PHOTOGRAPH:SouthWEATHER  
CONDITIONS:ClearTemp  $\approx$  70°f

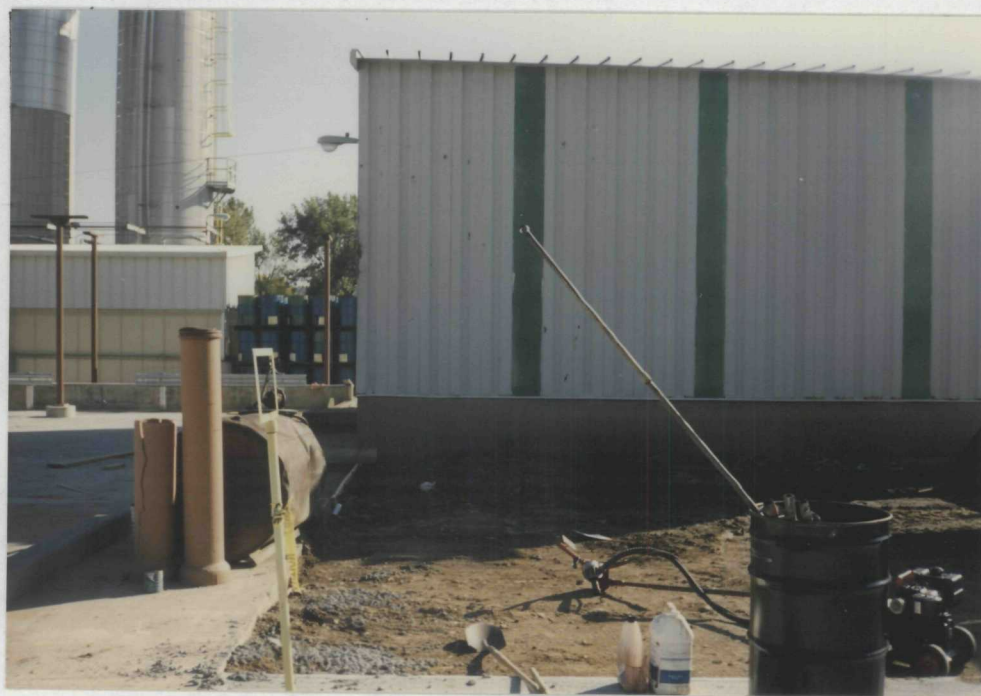
Cortney SchmidtSAMPLE ID  
(if applicable):S-2

DESCRIPTION: A perspective photo of soil Sample location  
S-2

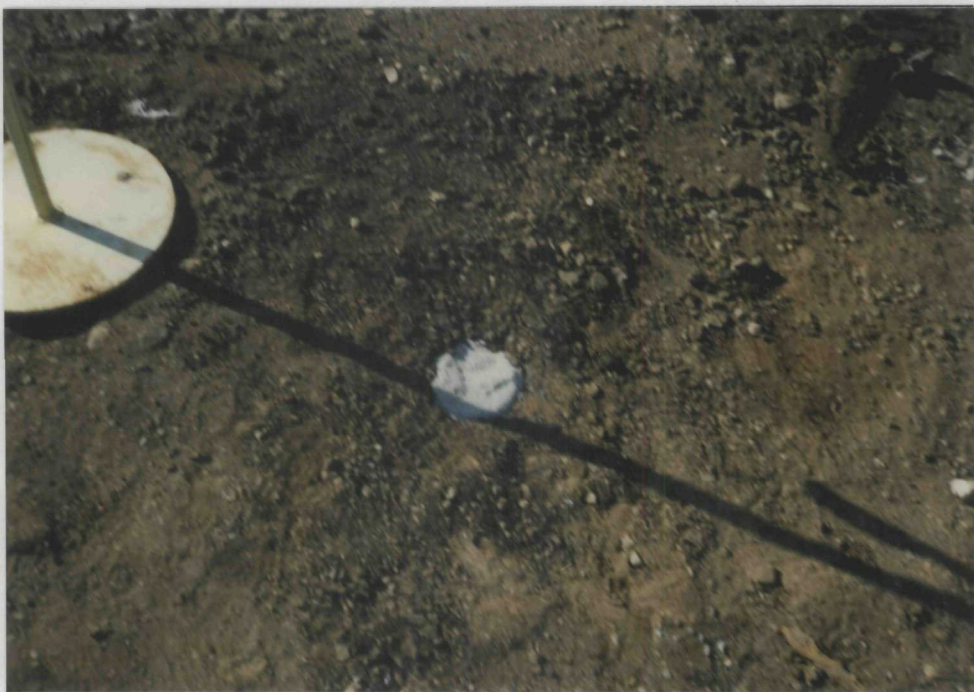
DESCRIPTION: A close-up photo of soil sample location  
S-2, the hole FIT dug was back-filled with bentonite.DATE: 10/2/90TIME: 10:00DIRECTION OF  
PHOTOGRAPH:SouthWEATHER  
CONDITIONS:ClearTemp  $\approx$  76°f

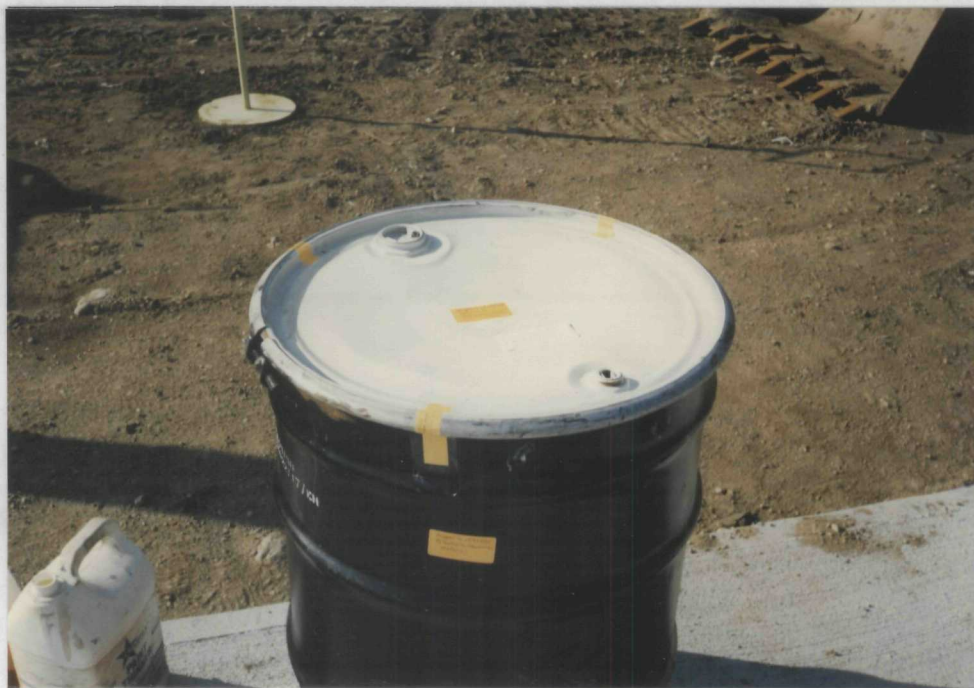
DESCRIPTION: A photo of sealed drum containing  
soil from deep soil samples S1 and S2 drilling.

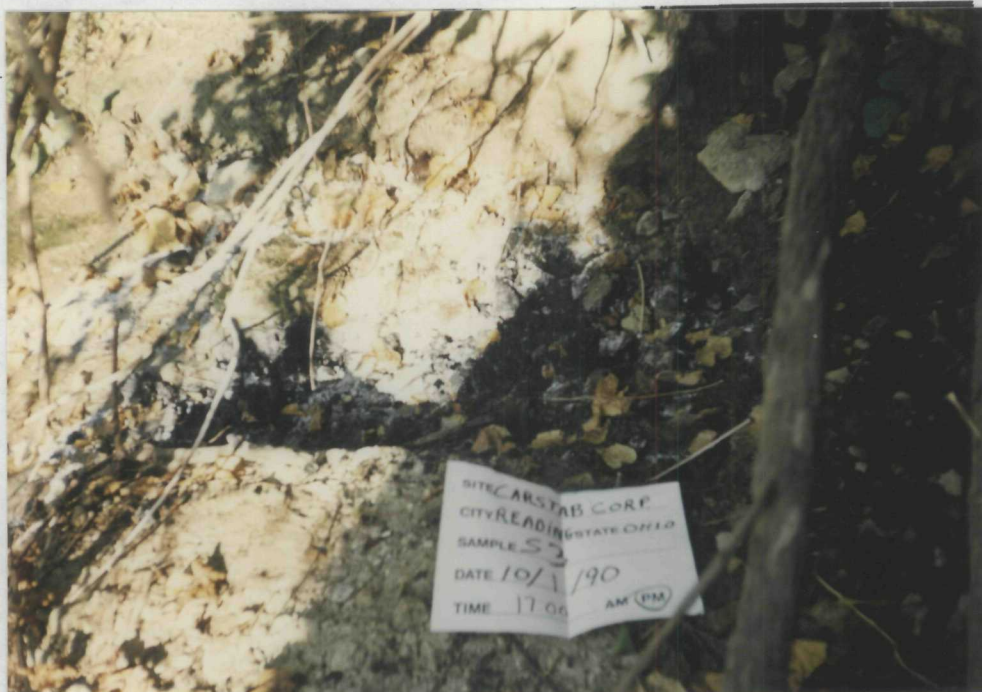
Cortney SchmidtSAMPLE ID  
(if applicable):S-3

DESCRIPTION: A close-up photo of Sediment Sample location  
S-3DATE: 10/1/90TIME: 1700DIRECTION OF  
PHOTOGRAPH:WestWEATHER  
CONDITIONS:ClearTemp  $\approx$  70°F

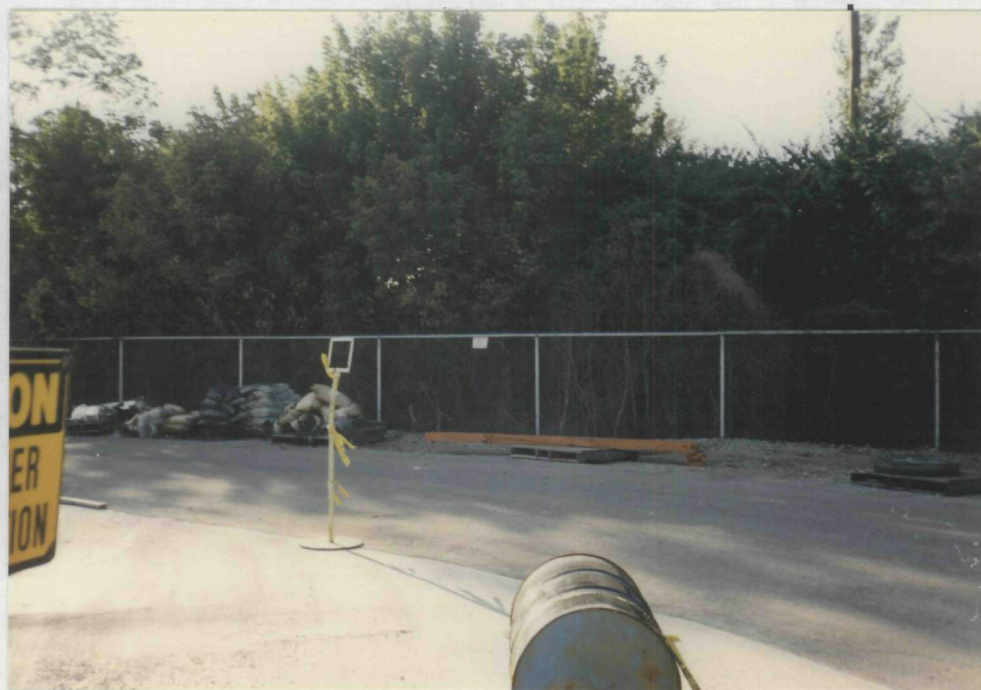
Cortney SchmidtSAMPLE ID  
(if applicable):S-3

Sediment sample S3 was collected off-site, adjacent to the northwest corner of the site. This surface sample was a grab sample collected from the east bank of Mill Creek, approximately 2 feet above water level, where a dry crystalline material was observed.

DESCRIPTION: A perspective photo of Sediment Sample location  
S-3

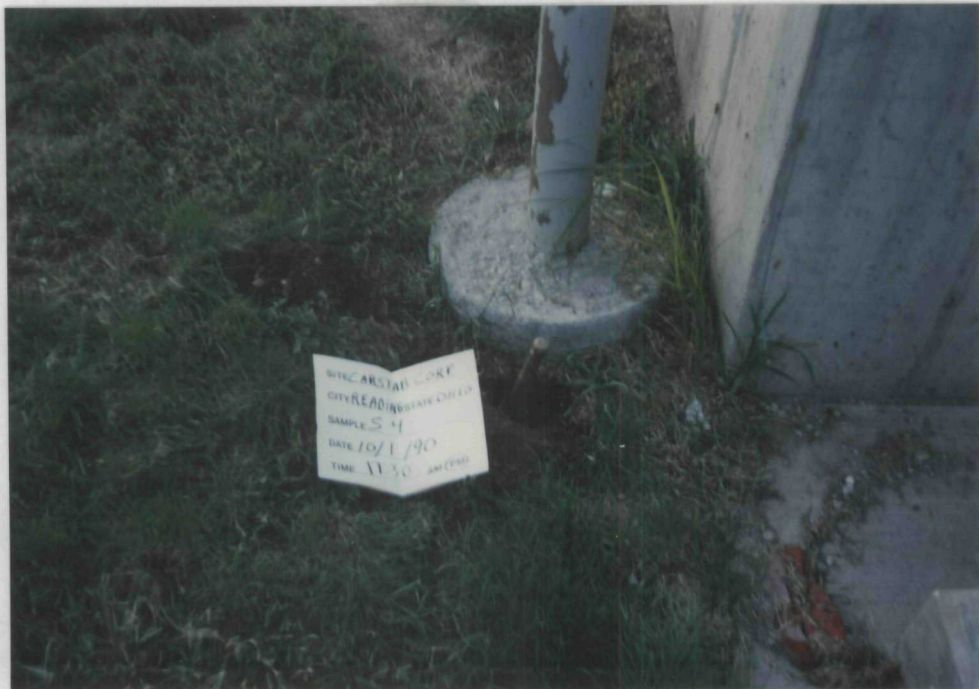
Cortney SchmidtSAMPLE ID  
(if applicable):S-4

DESCRIPTION: A close-up photo of soil sample location S-4.DATE: 10/1/90TIME: 1730DIRECTION OF  
PHOTOGRAPH:SouthWEATHER  
CONDITIONS:ClearTemp  $\approx$  70°F

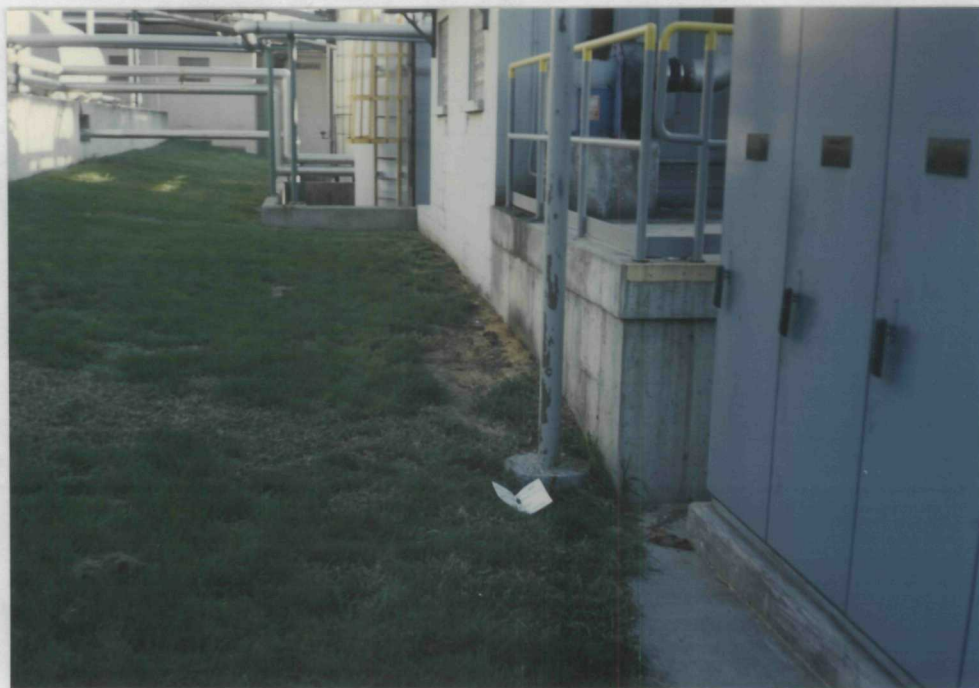
Cortney SchmidtSAMPLE ID  
(if applicable):S-4

Surface soil sample S4 was collected near storage tanks in the northeast corner of the site, from a location where spills from nearby storage tanks could potentially reach the soil. Surface soil sample S5 was collected from a ditch in the southeast corner of the site. Surface soil sample S6 was collected from an area of stained grass in the northwest portion of the site, immediately south of where raw materials are stored.

DESCRIPTION: A perspective photo of soil sample location S-4.

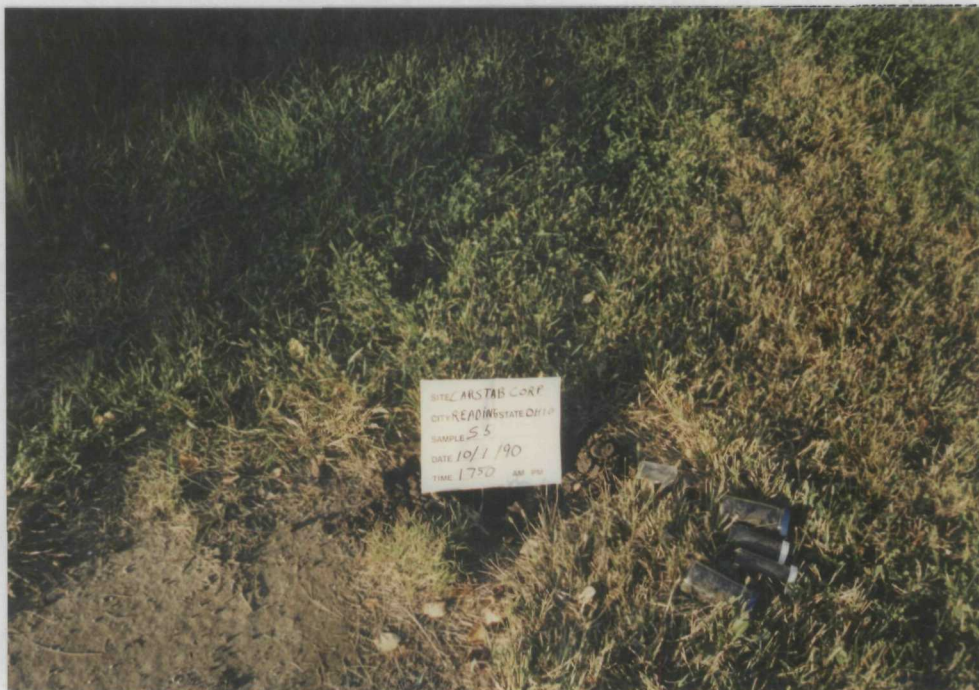
S-5

DESCRIPTION: A close-up photo of soil sample location S-5.

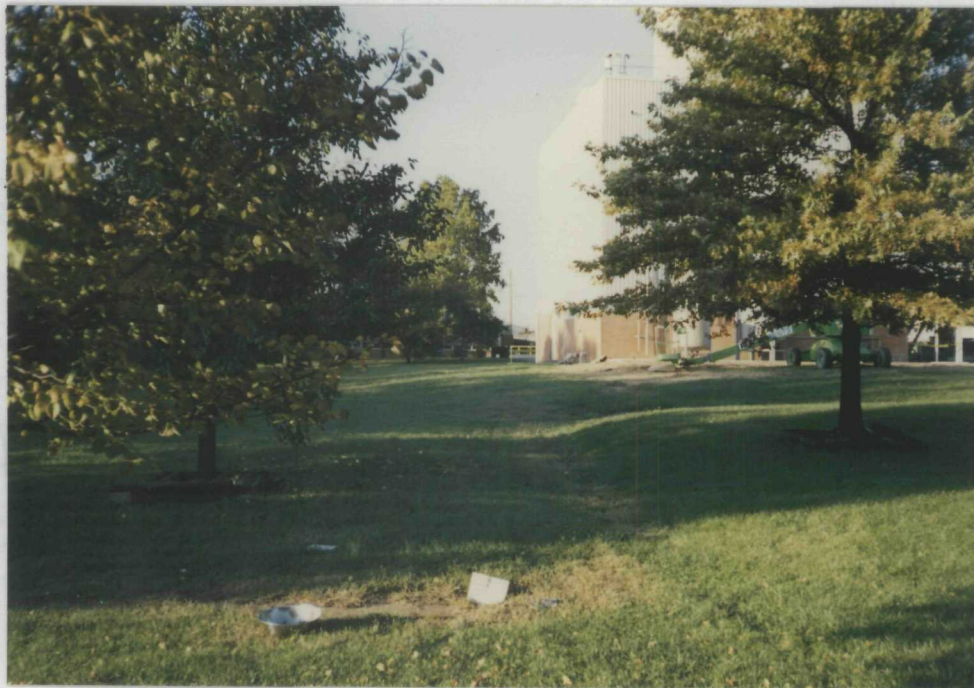
S-5

DESCRIPTION: A perspective photo of soil sample location S-5.

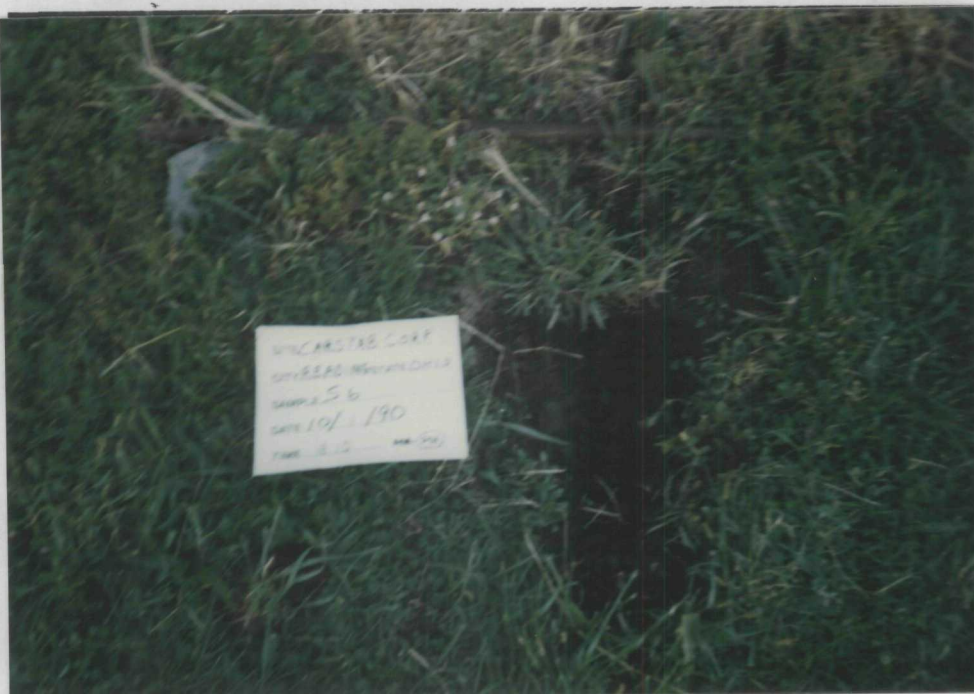
S-6

DESCRIPTION: A close-up photo of Soil Sample location S-6.

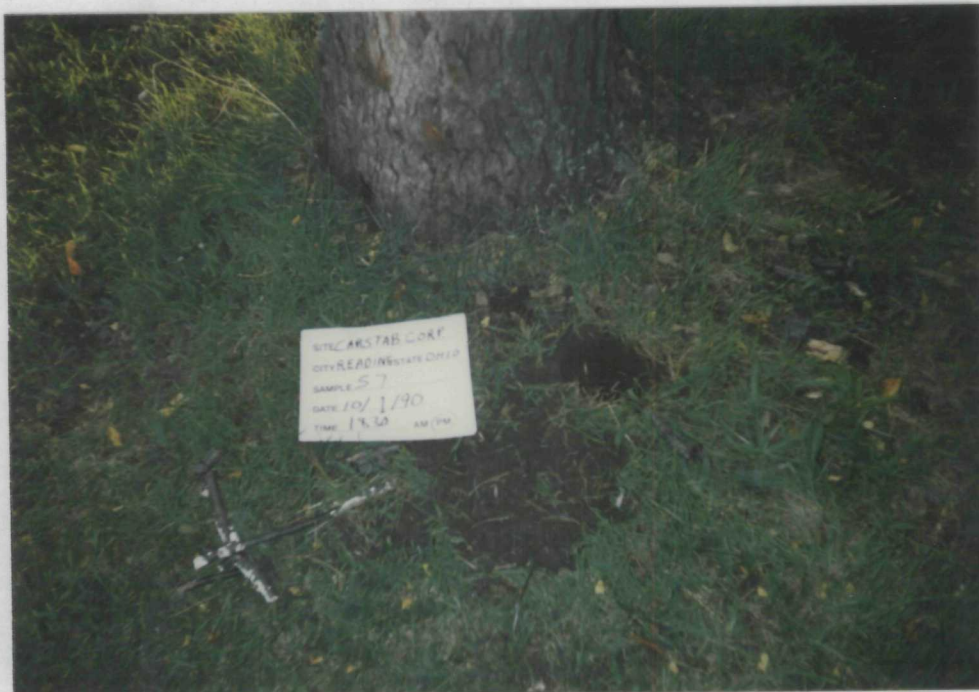
Nathan RussellSAMPLE ID  
(if applicable):S-7DESCRIPTION: A close-up photo of soil sample location S-7.

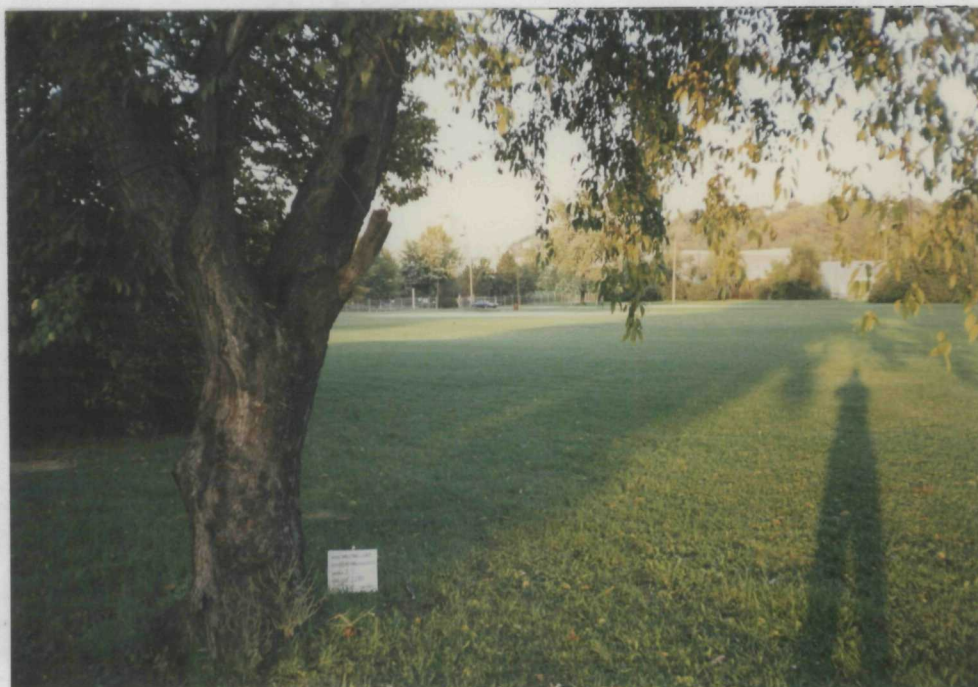
Nathan RussellSAMPLE ID  
(if applicable):S-7DESCRIPTION: A perspective photo of soil sample location S-7

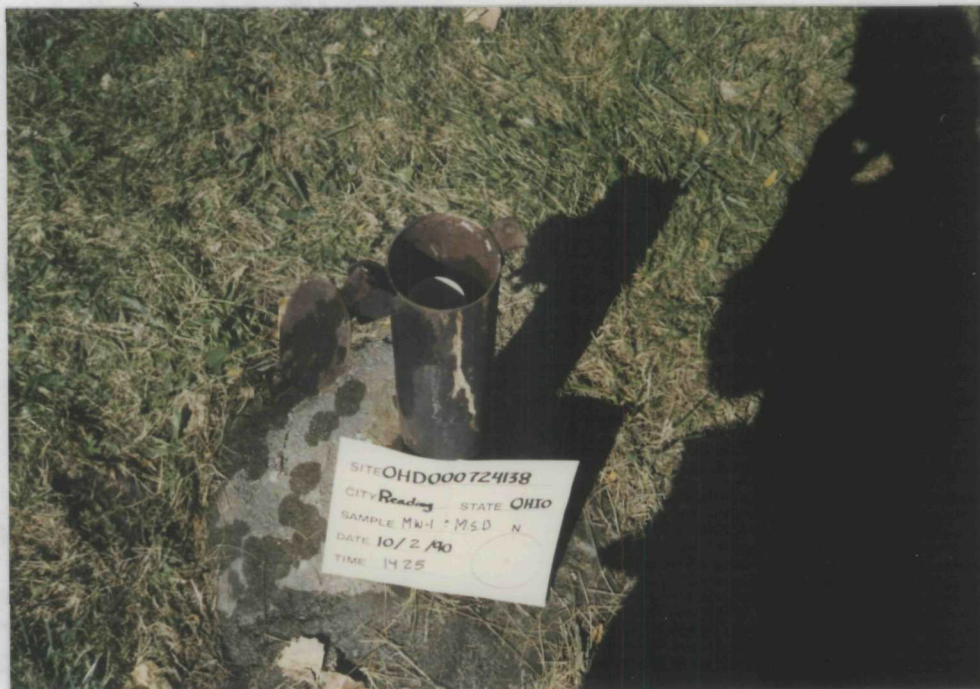
Cortney SchmidtSAMPLE ID  
(if applicable):MW-1  $\div$  M.S.D.

DESCRIPTION: A close-up photo of monitoring well sample  
location MW-1  $\div$  M.S.D.DATE: 10/2/90TIME: 14:25DIRECTION OF  
PHOTOGRAPH:NorthWEATHER  
CONDITIONS:Clear,Temp  $\approx$  76°F

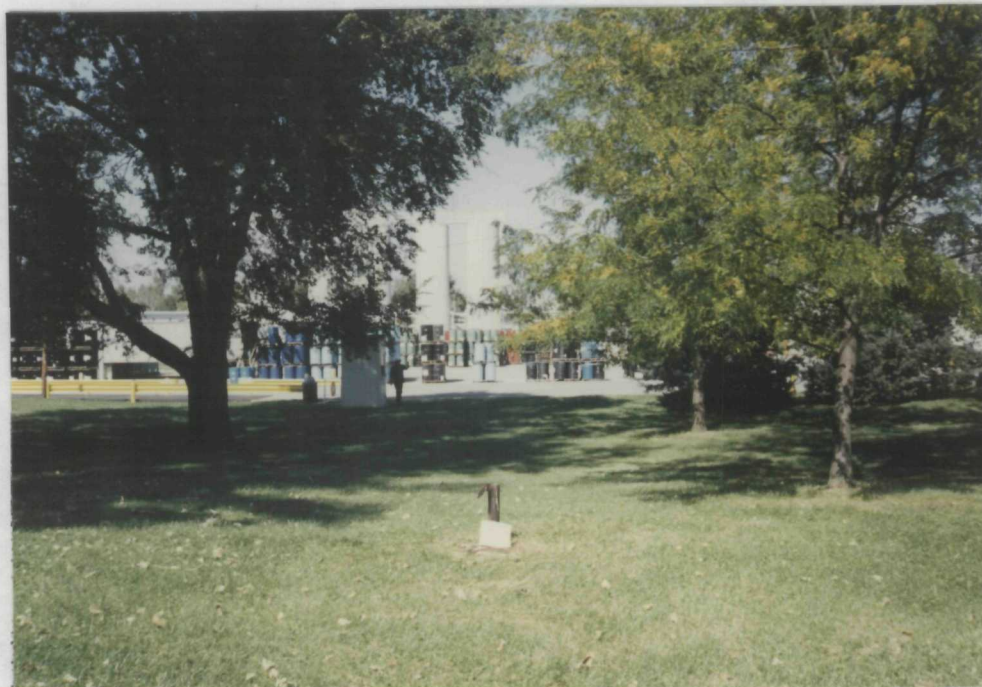
Cortney SchmidtSAMPLE ID  
(if applicable):M.W-1  $\div$  M.S.D

DESCRIPTION: A perspective photo of monitoring well sample  
location M.W-1  $\div$  M.S.D.

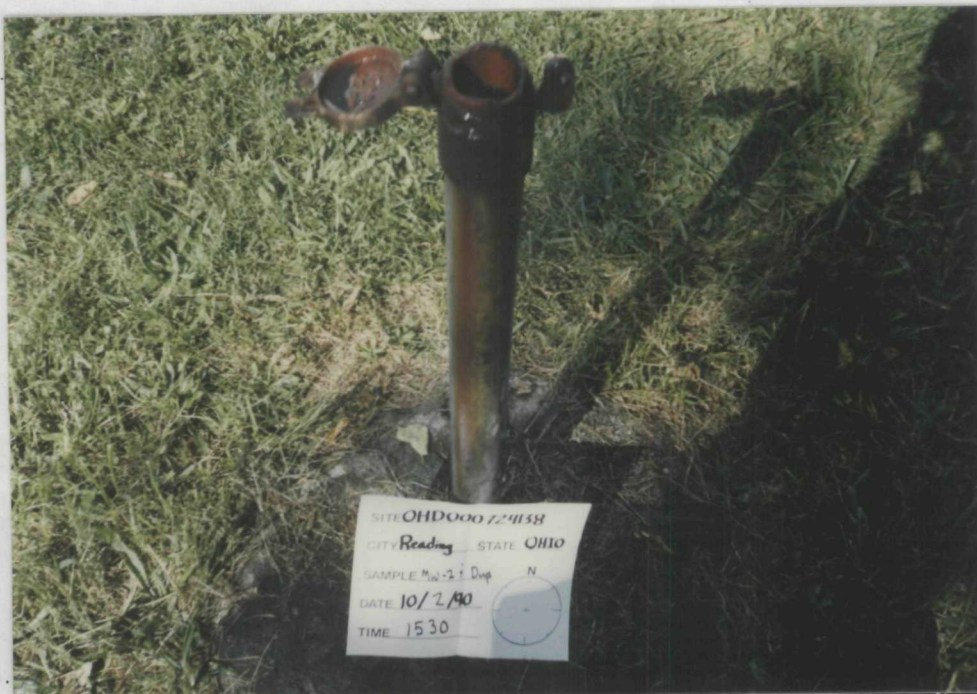
M.W. - 2 : Dup.

DESCRIPTION: A close-up photo of monitoring well sample location

M.W. - 2 and Duplicate.

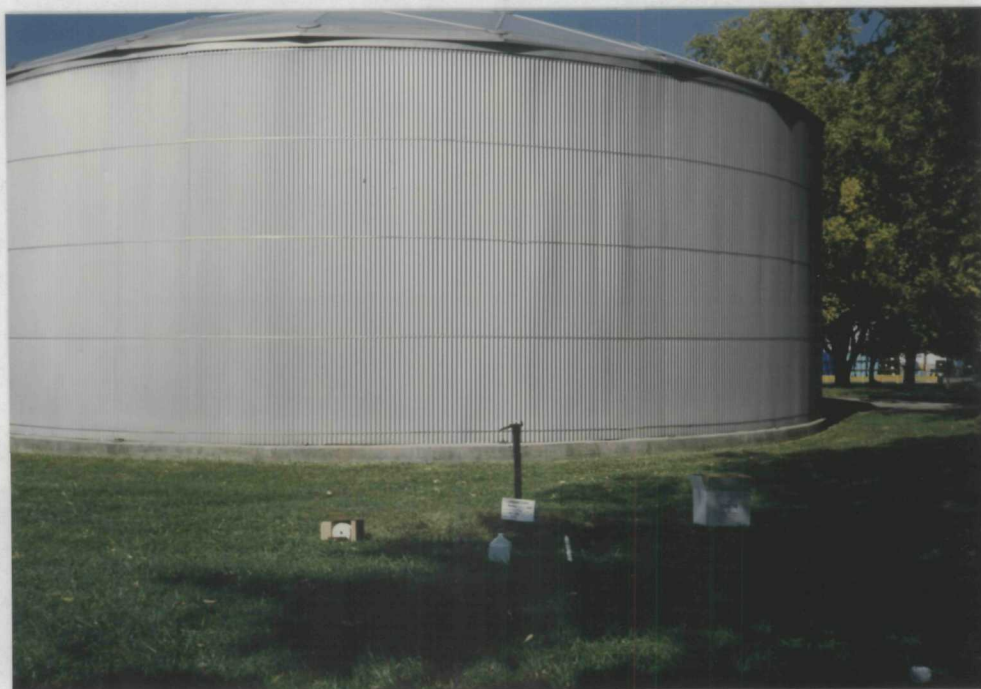
M.W. - 2 : Dup

DESCRIPTION: A perspective photo of monitoring well sample location

M.W. - 2 : Duplicate.

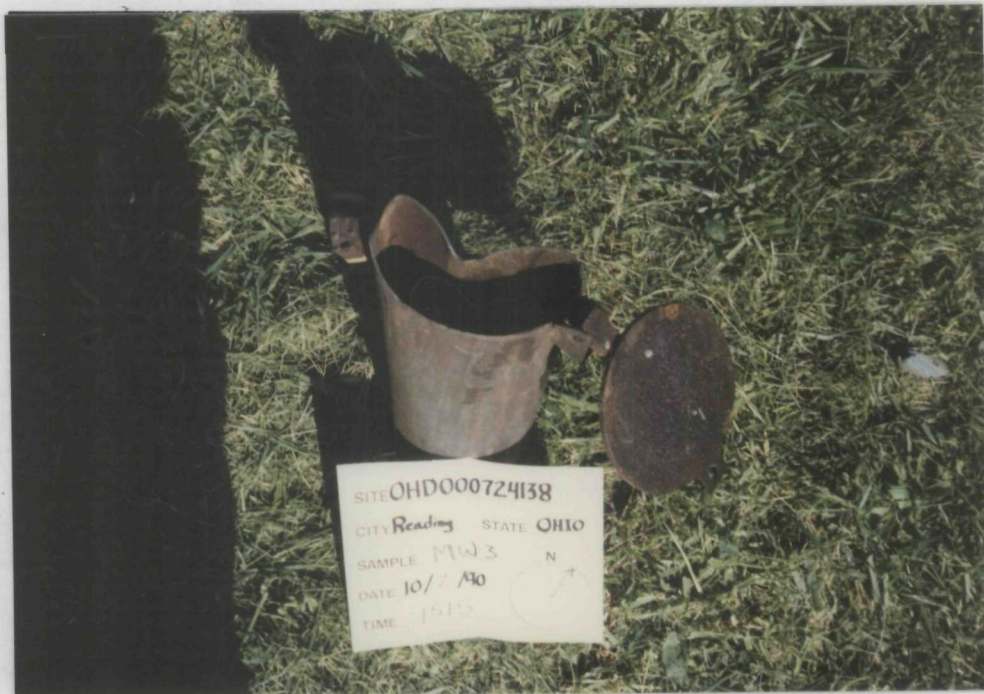
Cortney SchmidtSAMPLE ID  
(if applicable):MW-3

DESCRIPTION: A Close-up photo of monitoring well Sample location  
MW-3.DATE: 10/2/90TIME: 15:15DIRECTION OF  
PHOTOGRAPH:North EastWEATHER  
CONDITIONS:Clear,Temp  $\approx$  76°f

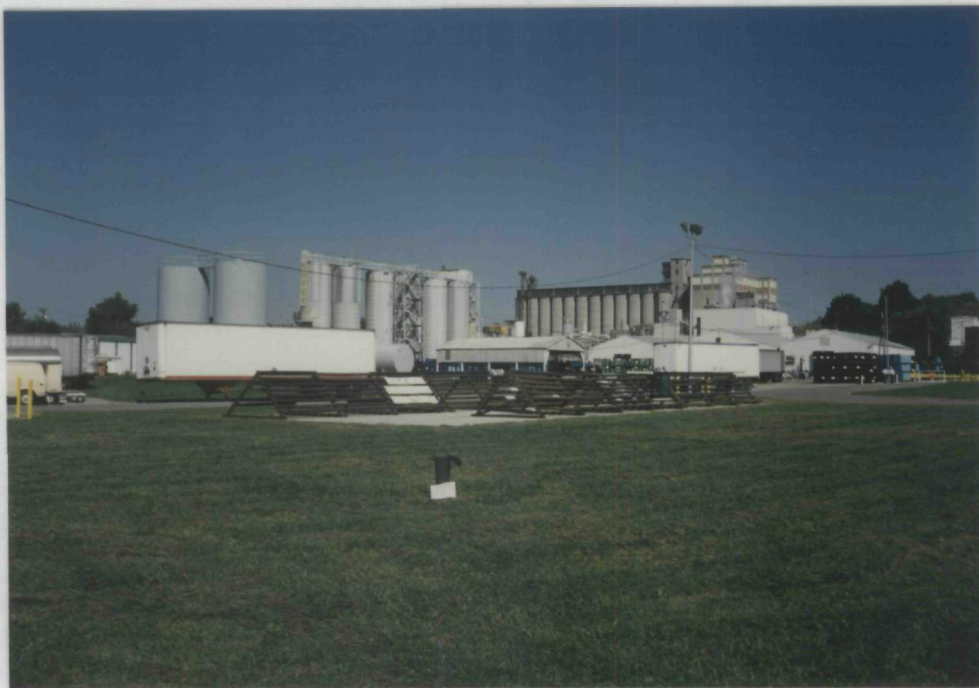
Cortney SchmidtSAMPLE ID  
(if applicable):MW-3

DESCRIPTION: A perspective photo of Sample location of Monitoring  
Well - M.W.-3.

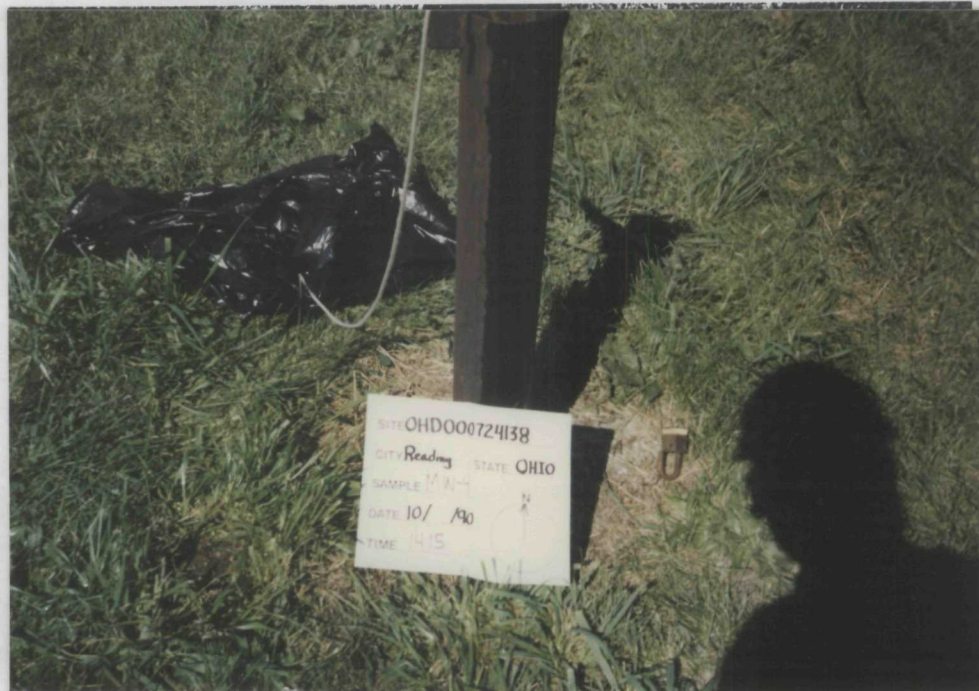
MW-4

DESCRIPTION: A close-up photo of Monitoring Well Sample location  
MW-4DATE: 10/2/90TIME: 14:15DIRECTION OF  
PHOTOGRAPH:NorthWEATHER  
CONDITIONS:Clear,Temp  $\approx$  76°F

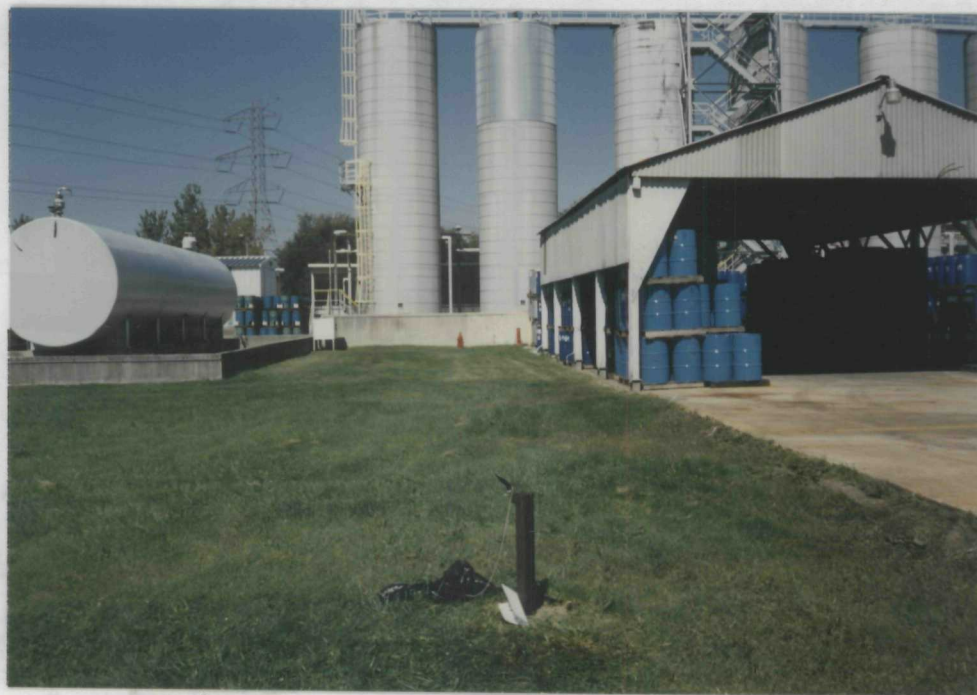
DESCRIPTION: A perspective photo of monitoring Well Sample  
location MW-4

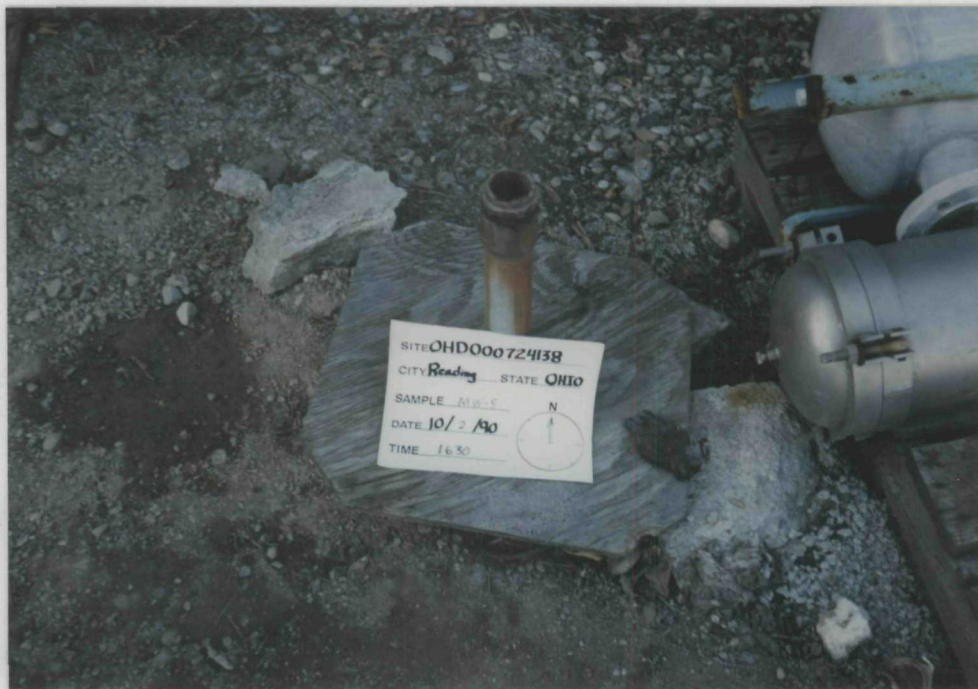
Cortney SchmidtSAMPLE ID  
(if applicable):MW-5

DESCRIPTION: A close-up photo of sample location for monitoring  
Well - M.W-5.DATE: 10/2/90TIME: 16:30DIRECTION OF  
PHOTOGRAPH:NorthWEATHER  
CONDITIONS:Clear,Temp  $\approx$  76°f

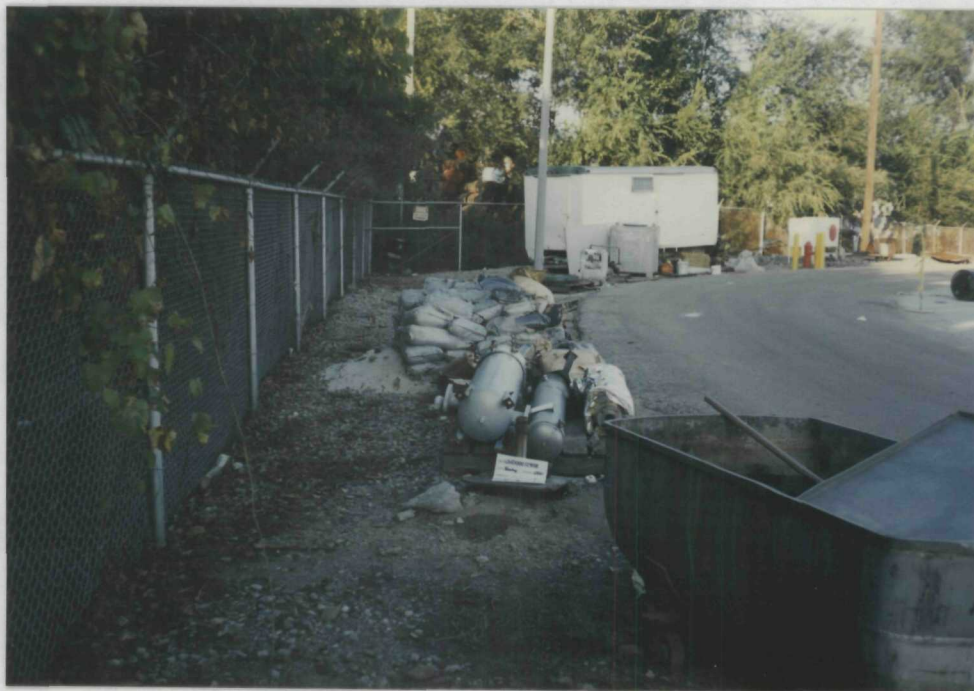
Cortney SchmidtSAMPLE ID  
(if applicable):MW-5

DESCRIPTION: A perspective photo of monitoring well sample  
location M.W-5.

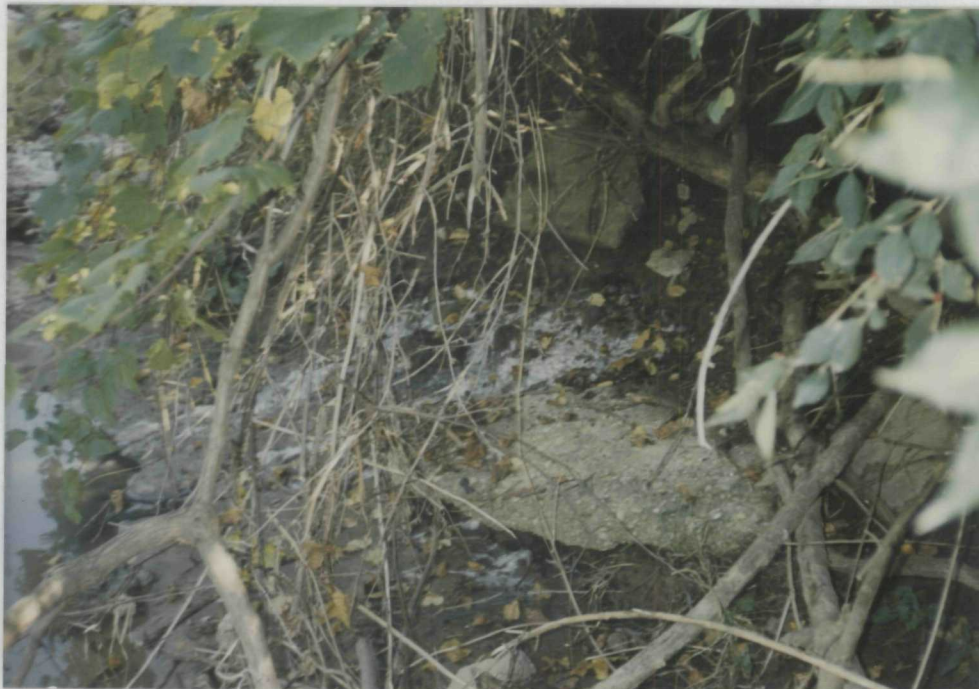
DESCRIPTION: A dried leachate seep, note the  
water in the lower left corner is mill creek.DATE: 10/1/90TIME: 12:50DIRECTION OF  
PHOTOGRAPH:NorthWEATHER  
CONDITIONS:Clear,Temp  $\approx$  70°f

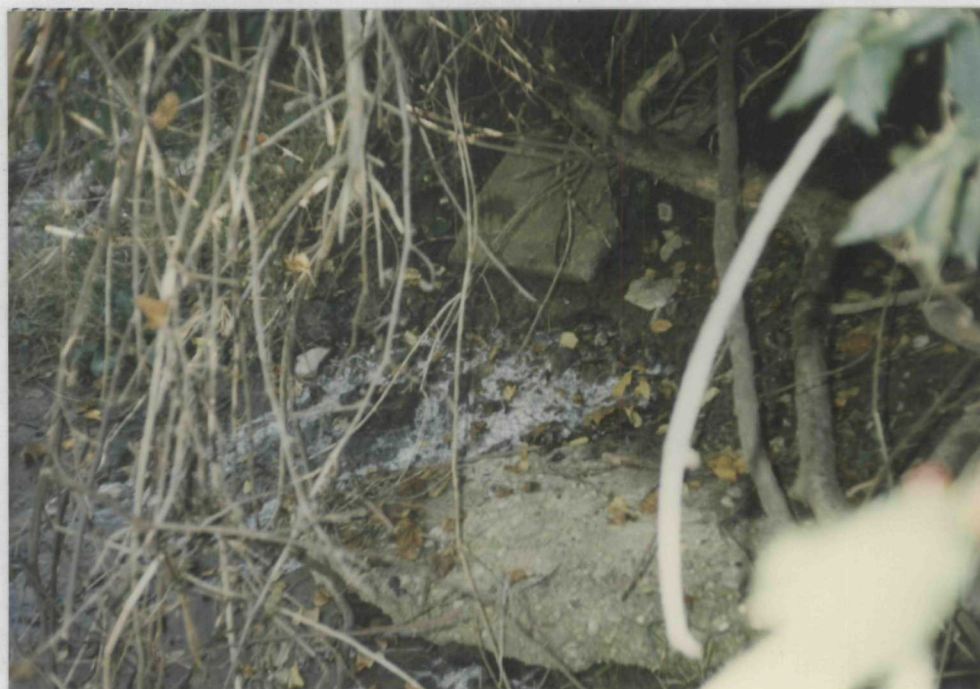
DESCRIPTION: Another photo of the dried leachate  
seep.

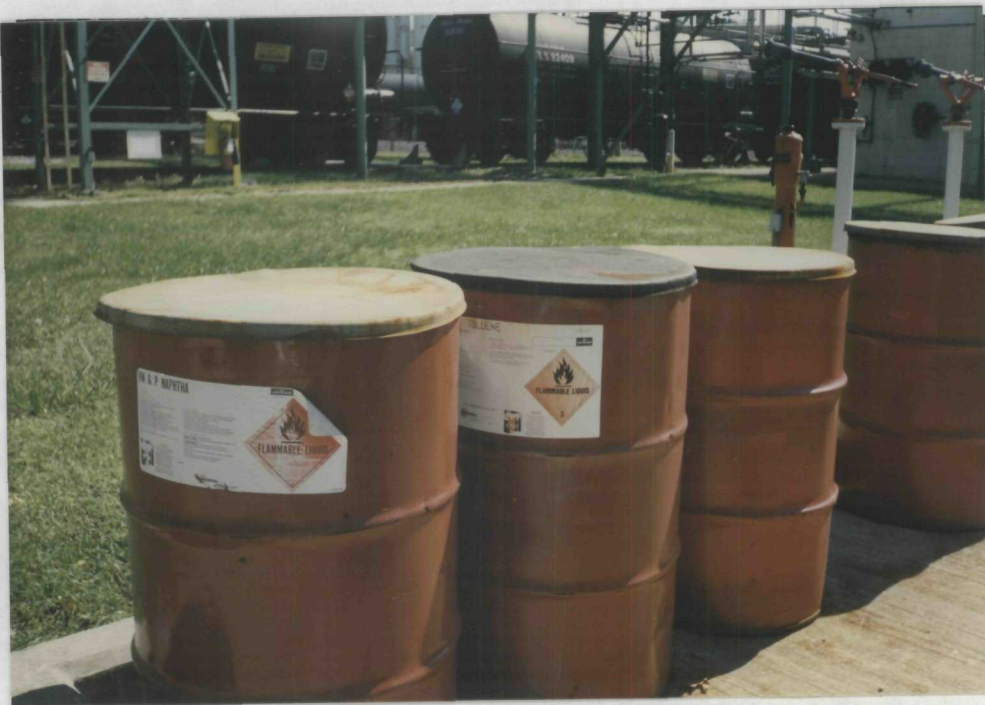
DESCRIPTION: A close up photo of Laboratory Solvents.DATE: 10/1/90TIME: 12:05DIRECTION OF  
PHOTOGRAPH:South eastWEATHER  
CONDITIONS:ClearTemp  $\approx$  70°F

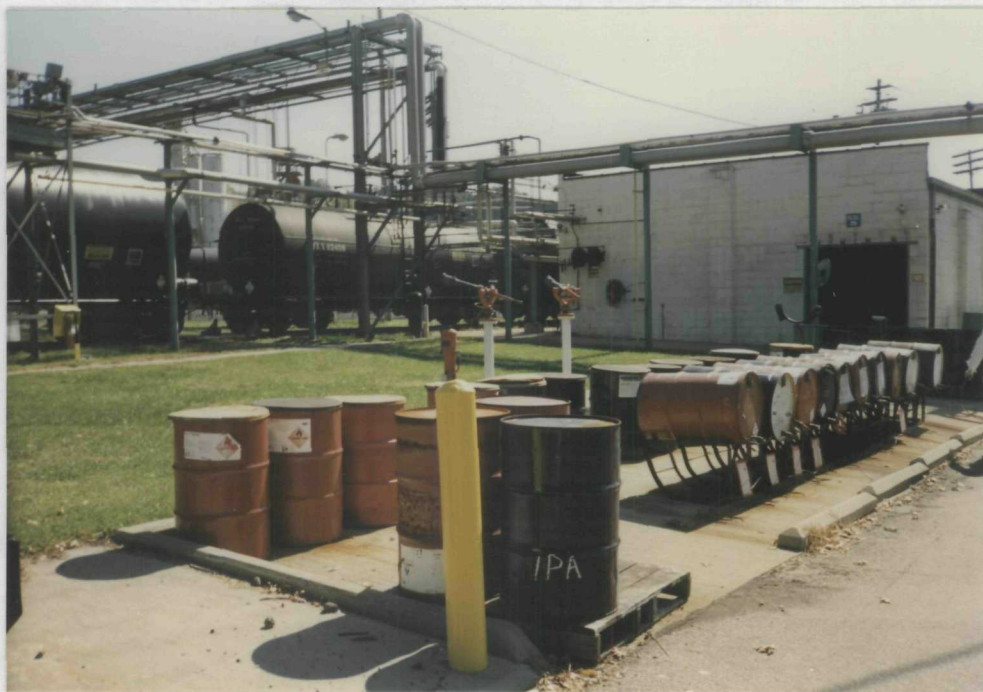
DESCRIPTION: A perspective photo of the Lab. Solvents.

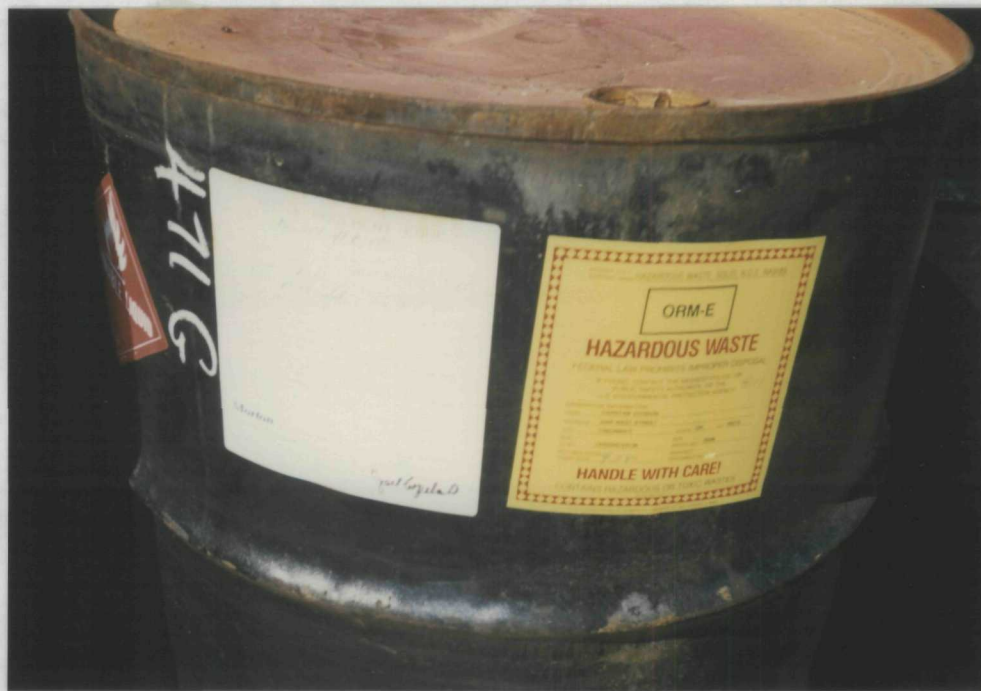
Approximately 150, 55-gallon drums of liquid hazardous waste are temporarily stored in the northwest corner of the site. Solid wastes are stored in plastic-lined cardboard boxes with "Cecos" on the label. There were approximately 25 boxes, approximately 1 cubic yard in size, adjacent to the drum storage area at the time of the SSI. Immediately south of this location is an area in which raw materials are stored.

DESCRIPTION: A close-up photo of a drum in the  
hazardous waste storage areaDATE: 10/1/90TIME: 11:48DIRECTION OF  
PHOTOGRAPH:South WestWEATHER  
CONDITIONS:ClearTemp  $\approx$  70°F

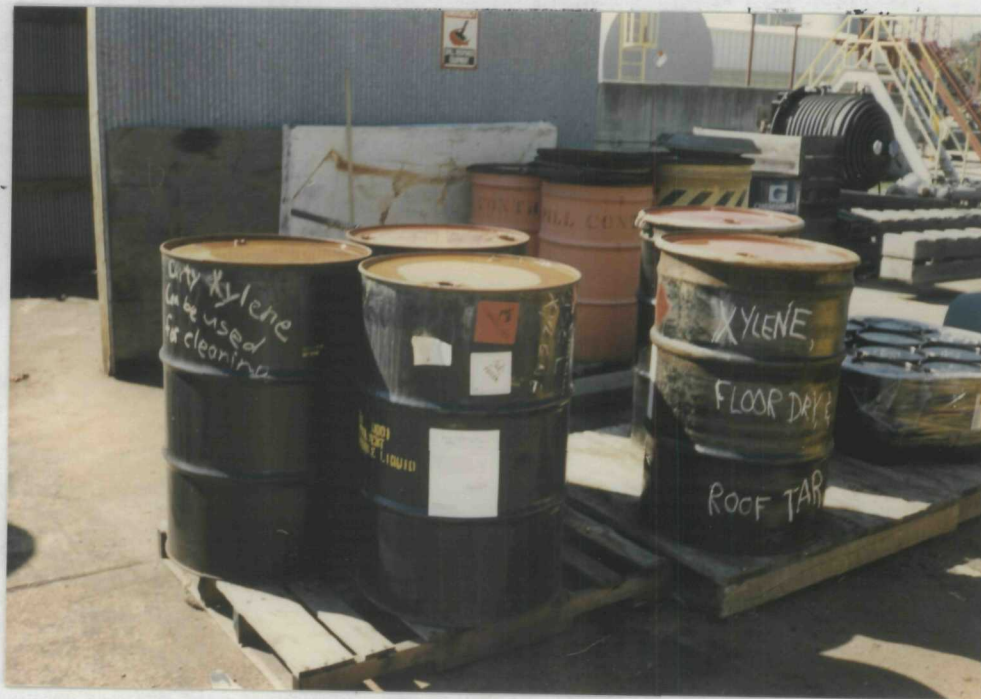
DESCRIPTION: A close-up photo of xylene in drums  
stored in the Hazardous Waste Storage area.
